CASE STUDY: LIGHTHOUSE**LOCATION:** GUINCHO PORTUGAL**MARKET:** MARINE

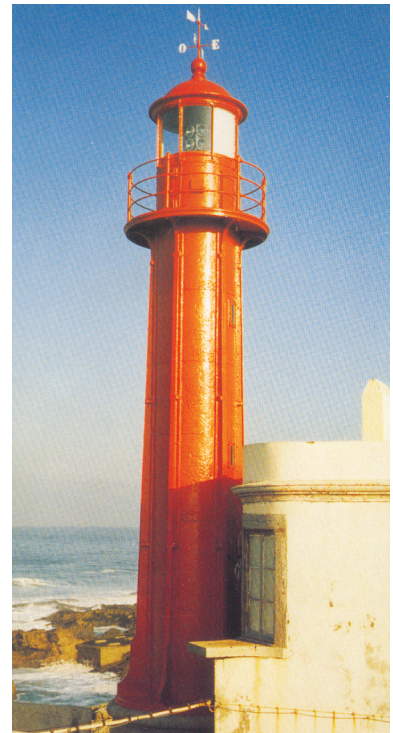
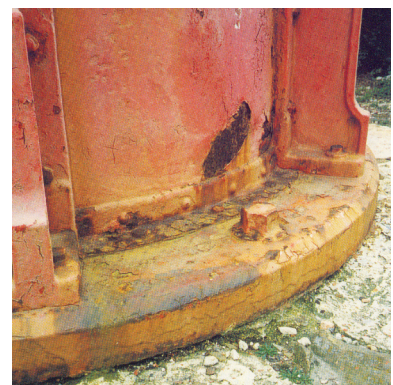
REQUIREMENT: The client was responsible for the maintenance and upkeep of all the lighthouses on the Atlantic coast of Portugal. This lighthouse at Guincho, 25km NW of Lisbon, was more than 100 years old and was constructed from cast iron with a copper roof. Heavy air borne salt and strong winds created a particularly aggressive coastal environment. Additionally, UV light also affects the colour retention.

SURFACE PREPARATION: Surfaces were hand prepared to St2 standard of EN ISO 8501-1:2007 using a combination of wire brushes, scrapers and mechanical tools followed by Hydro blasting to remove salt contamination.

COATINGS: DFT**Externally:**

Corroless EPF Buff	200 microns
Corroless RF65	50 microns
Corroless RF65	50 microns

Finally when the coatings were cured all bolts and crevice areas were then treated with CCI450 by brush.
