**CASE STUDY: PRIMARY SETTLEMENT TANK**

**LOCATION:** WALES UK

**MARKET:** UTILITIES

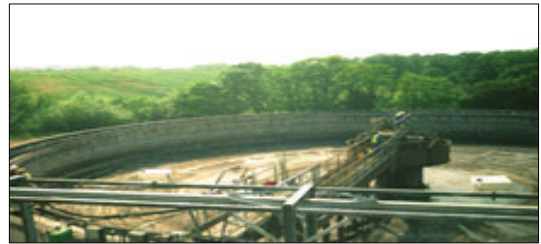
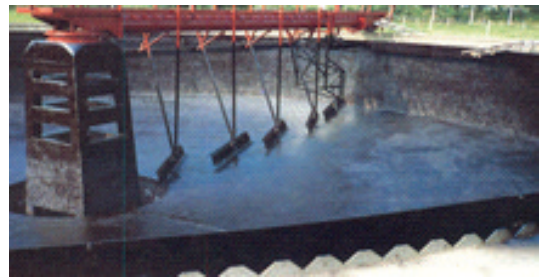
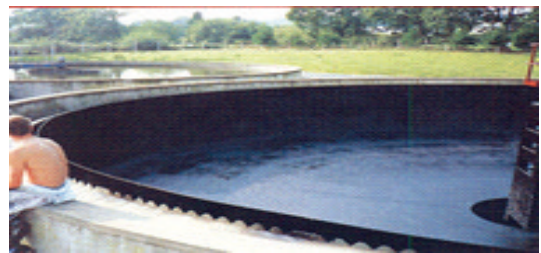
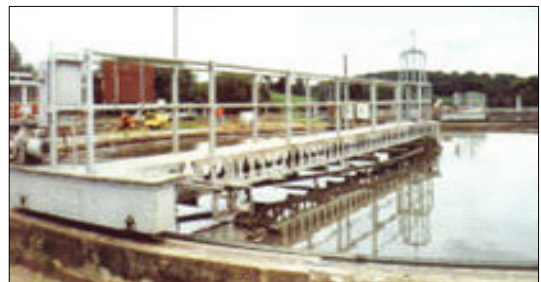
**REQUIREMENT:** To overcome the corrosive effects of moisture, chemical contamination and raw sewage, the client had specified a full range of Corroless systems at its Water Treatment Works. Concrete primary settlement tanks based upon a radial design were suffering from severe corrosion, abrasion and delimitation. The sludge sticking to the sides of the tanks was slowing down the operation of the scraper blades and using additional power. Customer required the concrete to be protected and a hard, smooth, abrasion resistant surface created to stop sludge build up on the tank surface and scraper blades.

**SURFACE PREPARATION:** The tanks were high-pressure water jetted to remove laitance and loose material. The damaged surface and blowholes were repaired where necessary prior coating. The scraper bridge was prepared using hand tools.

**COATINGS:** The tank and bottom of the scraper bridge were treated with 2 coats of Corroless EPF. The top of the scraper bridge was treated with a coat of Corroless EPF and two coats of Corroless RF65.
