**CASE STUDY: RAILWAY STATION STEEL WORK****LOCATION:** CUMBRIA**MARKET:** BRIDGES**REQUIREMENT:**  
REFURBISHMENT OF STATION STEEL  
WORK.**SURFACE PREPARATION:**

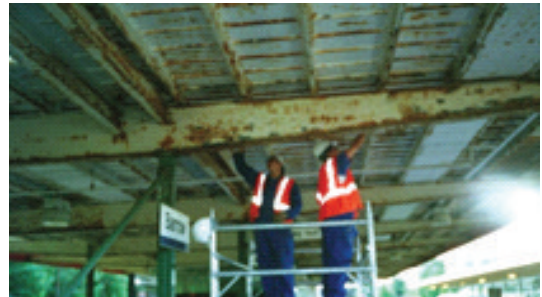
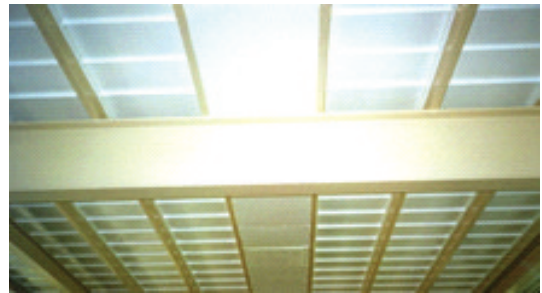
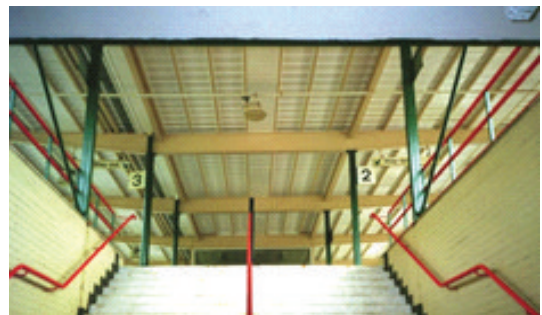
Surfaces degreased and pressure jetted to remove salt contamination prior to hand preparation to St3 standard of EN ISO 8501-1: 2007.

Surfaces then steam cleaned to ensure full removal of salt contamination.

Tests for salt carried out prior to coating.

A primer coat of Corroless EPF and a top coat of Corroless RF65.

Stripe coats were applied where appropriate for both coats

<b>PRODUCT:</b>	DFT
Corroless EPF Buff	200 microns
Corroless RF65 (varied)	50 microns
