Plascoat PPA 571

The tale of two coatings in Indiana, USA

Jackson Bridge, Muncie, Indiana; Railings and columns coated in Plascoat PPA 571

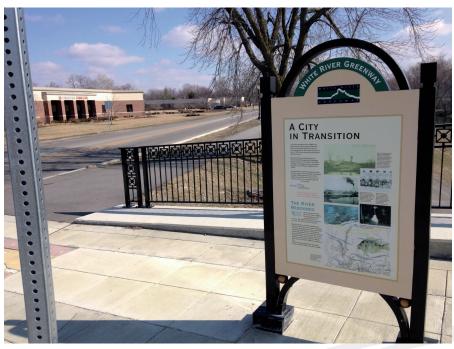
Plascoat PPA 571 was used to coat the frame of this public information board.

Plascoat PPA 571 is highly resistant to road salt and stone impact damage. It also has extremely good flexibility and adhesion properties allowing the coating to protect sharp edges.
